## Erosion Scars Caused by Earth Flows - A Case Study from Central Kenya

**Abstract:** Earth-flow features are described on a small-holder farm in Nyandarua District (Central Kenya), where over 900 earth flows occurred with most of the farms (>50 %) in the region being affected. Individual flows affected areas from a few square metres to two hectares. In the area, the earth-flow features occurred exclusively on grazing land and on convex slopes, and are the result of extremely slow processes. The first visible signs are usually shallow scars along the contour, breaking the grass vegetation. Subsequent mass movement is very slow and gradual. According to old area residents, some of these earth-flow features have been observed as long as 60 years ago. Because of the extremely slow development, it was not possible for the local residents to date the earthflows; these earth flows “had always been there”. Therefore, these features could not be attributed to recent (<30 years) land-use changes. One earth flow studied in more detail revealed that soil stratification, impeded drainage leading to oversaturation of the top soil layers, and seasonal sub-surface flow seemed to be mainly respo

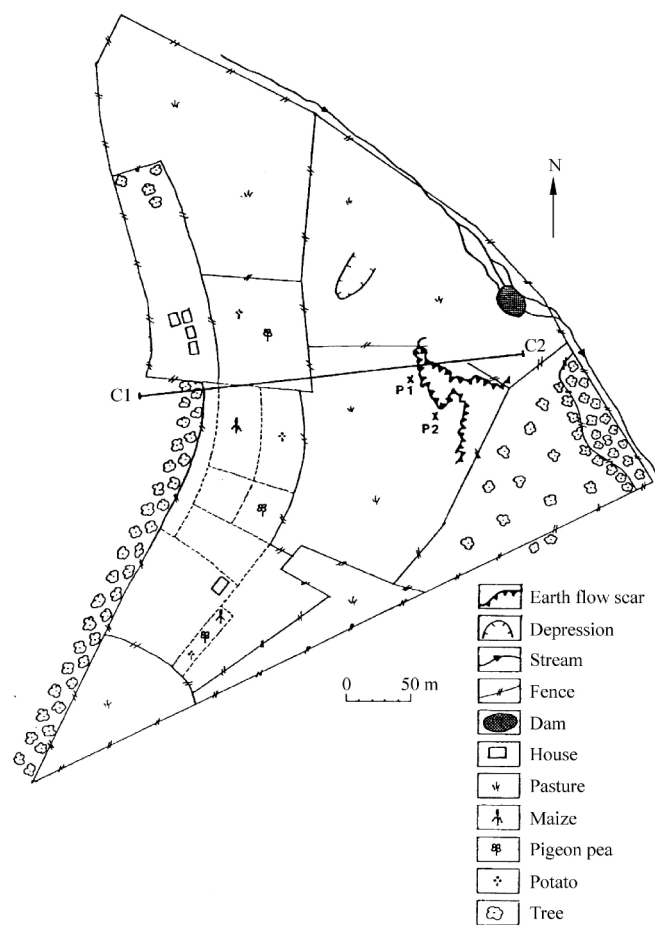
**Fig. 4** Githinji farm in Nyairoko, Ol’Joro Orok area. The soil catena is marked C1-C2, soil-profile pits are marked P1 and P2

The farm has a total area of approximately 12 ha, is situated on a 10° slope facing Northeast, and ranges in altitude between 2,700 and 2,750 m. The lower end of the farm borders the valley bottom, where just within the lower farm boundary, a small dam was built to secure drinking-water supply from a seasonal stream. About 20 % of the farm is used for crops (maize, potatoes, green peas); the remaining area is grassland. A herd of 15 cattle are kept on the farm.

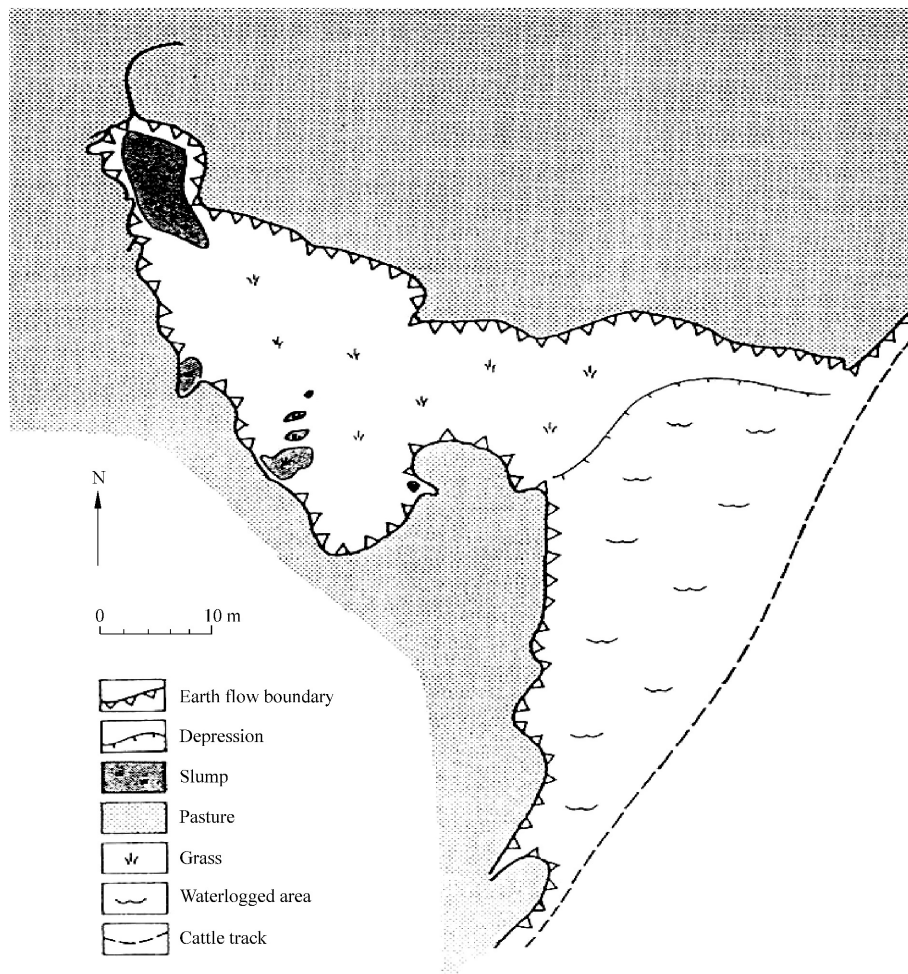
**Fig. 5** Map of the earth-flow scar

The erosion scar is situated at the lower part of the farm, facing 60° east (Fig.5). The slope section containing the scar was convex with an average steepness of 13°. The erosion scar had a total surface area of 1984 m<sup>2</sup> (approx. 0.2 ha) and a horseshoe-like shape. Its maximum depth was 4.4 m. Just above the head of the scar were several parallel just-recognizable furrows which drain water into the scar during rainfall. The northern part of the scar extended by a gully-type form of head-wall collapse. A section of the northwestern vertical escarpment had collapsed. During high-rainfall periods, water emerges at various points along the escarpment, some of it from small soil pipes. During these periods, this part of the earth-flow scar is permanently waterlogged.

Inside the scar, patches of grass were growing. Some of the grass was established by the farmer, who also planted a few eucalyptus trees. The land around the scar is pasture. No particular measures to protect and heal the scar were being taken. The total volume of soil estimated to be lost by the earth flow is 3,380 m<sup>3</sup>. However, no signs of soil deposition were observed in the natural drainage way.

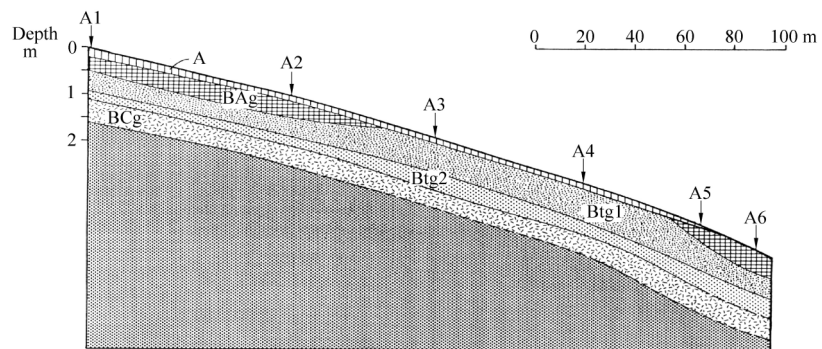
**Fig. 6** Catenary horizon diagram for slope C1-C2 (refer also to Fig. 4)

The seepage layer was approximately 0.2 m wide and intersected by four to five silt layers of 2—3 mm thickness. Faunal activities were sparse. After horizon identification, a soil catena was drawn from auger information (Fig.6).

The grain-size distribution, silt/clay ratio and clay ratio showed little differences between the two profiles (Table 1). More erodible layers, i.e., higher silt/clay ratios occurred at depths between 0.1 and 0.6 m. At the lower part of the slope, at around auger holes 5 and 6 (Table 2, Fig. 6), texture tended to be finer than on the upper part, possibly due to slow surface erosion and deposition processes. The change in texture along the slope, however, also influences bulk density, and therefore reduces infiltration and hydraulic conductivity. Hence, layers of finer texture will create relative water barriers to guide seepage-water flow. The overlying layers of higher erodibility (i.e., higher silt/clay ratio) would then easily attain their liquid limits and begin to flow.
