Vegetation Destruction and Restoration Effects on Soil Erosion Process on the Loess Plateau

Zheng Fenli, Tang Keli, Zhang Cheng-e and He Xiubin

Institute of Soil and Water Conservation, Chinese Academy of Sciences and Ministry of Water Resources,
Northwestern Sci-Tech University of Agriculture and Forestry, Yangling, Shaanxi, China
E-mail: flzh@ms.iswc.ac.cn

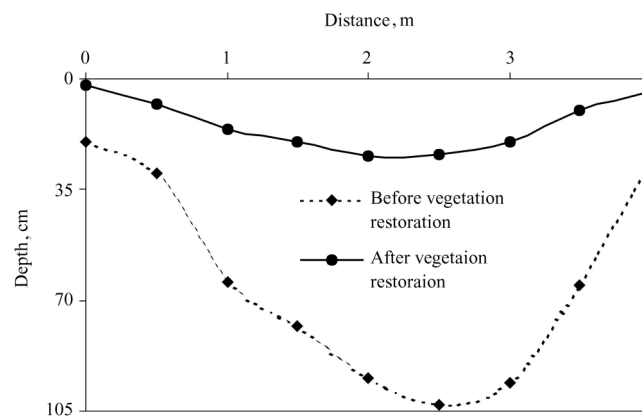
Fig. 1 The cross sections of an ephemeral gully channel before and after the secondary vegetation restoration (the space between two cross sections represented sediment deposition)

More than 130 years ago, population in the Ziwuling region moved out to other places due to nationality dispute, the secondary vegetation has gradually evolved, forming to today's landscape with green mountains and clear rivers. According to field investigation, the secondary vegetation firstly grew at depression locations where soil moisture condition was better than other topographic locations. On the hill slopes, vegetation grew earlier in ephemeral gully channels than at hill slopes. Similarly, vegetation grew earlier in gully bottom or valley bottom than on gully slopes or valley slopes. After the secondary vegetation was growing at the depression locations, soil erosion at these locations was reduced by vegetation. Meanwhile, eroded sediment from hill slopes and gully slopes or valley slopes was captured at the depression locations by growing vegetation, which caused eroded sediment was deposited in ephemeral gully channels on hill slopes and gully bottoms on gully slopes. Figure 1 showed that the depth of sediment deposition at ephemeral gully channels on hill slopes reached 60cm to 70cm during the secondary vegetation restoration, and the depth of sediment deposition in gully bottom or valley bottom was more than 100 cm. In addition, sediment deposition in ephemeral gully or gully bottom caused that slope surface tended to be leveled, which resulted in reduction of sheet erosion and rill erosion, and sediment transport rate from hill slopes to ephemeral gully channels or from gully slopes to gully bottoms.

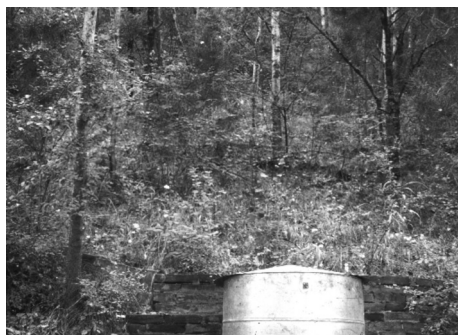
Fig. 2 Natural erosion under current vegetation cover

The data from field runoff plots (Table 2 and Table 3) showed that under current vegetation cover, soil loss from woodland was very slight (Figure 2), and effects of rainfall and slope degree, and slope length on soil erosion were not obvious. This indicated that in the Ziwuling region, vegetation effect on soil erosion occupies a predominant position.

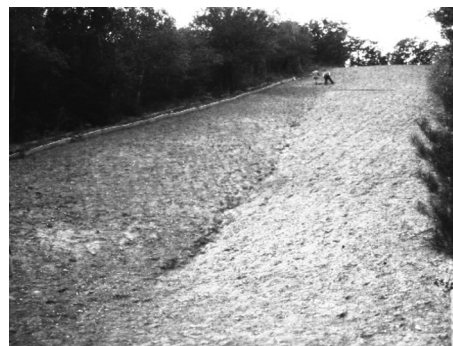
Fig. 3 Accelerated soil erosion (rill and ephemeral gully erosion) on a hill slope after the secondary vegetation destruction

After conversion of woodland to cropland, rill erosion and ephemeral gully erosion was dominated at hill slopes (Figure 3). Rill erosion was 3,400 t/(km² • yr) to 6,700 t/(km² • yr), occupying above 30% of the total soil loss, ephemeral gully erosion was 7,200 t/(km² • yr) to 12,600 t/(km² • yr), taking up above

52% of the total soil loss. On the gully slopes, gully erosion, such as gully head-cuts, gully channel deep cutting, and gully sidewall collapsing was dominated. Meanwhile, after woodland was converted to cropland, rainfall and topography significantly affected accelerated erosion (Table 3).
