SOIL CONSERVATION PRACTICE – IN SEARCH OF EFFECTIVE SOLUTIONS

R.J. Loch^A

^A Landloch Pty Ltd, Toowoomba, Australia.

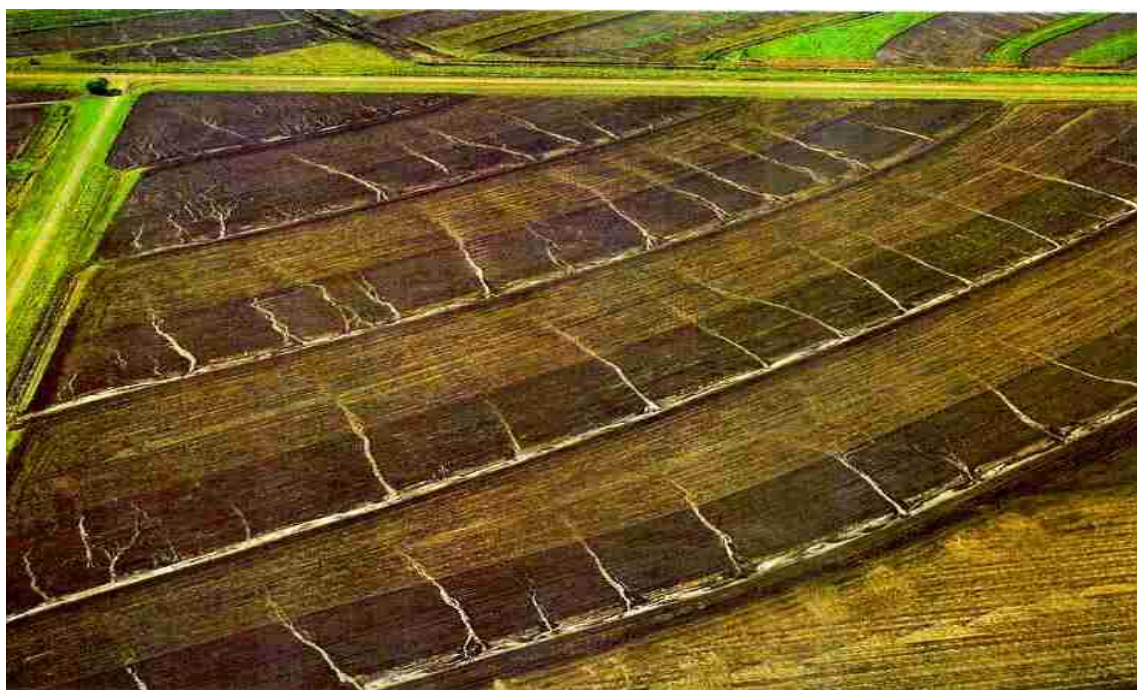
Figure 1. Widespread rilling between graded banks

However, by the early 1980's, it was plain from both observation and research data that the main soil conservation approach being applied was not successful in controlling erosion. Research data indicated erosion rates of 30-60 t/ha/y between graded banks (Freebairn and Wockner 1986), and heavy rilling was clearly visible between graded banks (Figure 1). The main options considered were to either (a) recommend a halving of the spacing between graded banks, or to (b) encourage the greater adoption of stubble retention and reduced tillage. These options were not necessarily mutually exclusive, and both were being encouraged to greater or lesser degrees at that time.

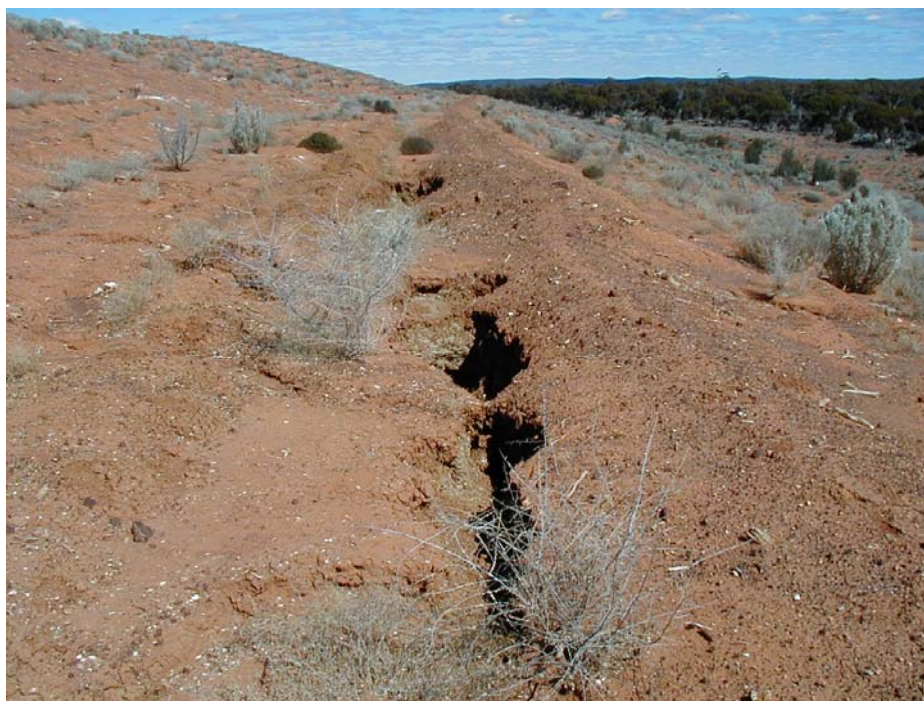
Figure 2. Tunnel development due to ponding of water in a berm on a mine waste rock dump.

The major erosion control practice adopted (berms to reduce slope length) has been spectacularly unsuccessful in situations where there is potential for tunnelling to develop. Ponding of water in berms has been a major factor in the initiation of tunnels (Figure 2). In the longer term, berms have failed and gullied even when tunnelling did not occur, simply because such structures require regular maintenance, and such maintenance does not occur on rehabilitated minesites. A more long-term view is gradually becoming adopted, with some sites now considering waste dump stability for periods up to 200 years. As well, all “flow control” structures are designed to some “return period”, so there is an element of certainty in their failure. (Sooner or later, the design storm will be exceeded.)
