PREDICTIVE CAPABILITY TO ASSESS MILITARY TRAINING IMPACTS ON MILITARY INSTALLATION STREAMS UTILIZING REMOTE SENSING

Integrated Training Area Management, Fort Riley Military Installation, Fort Riley, KS

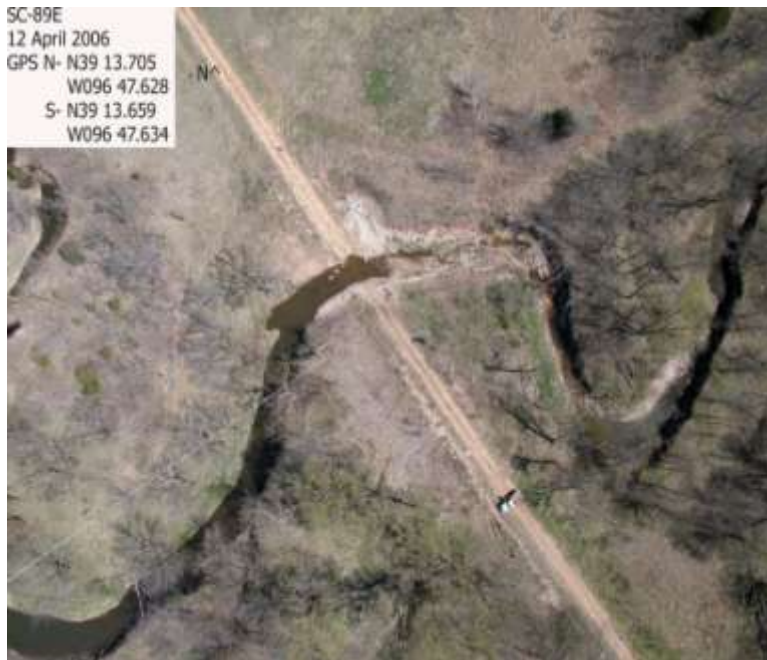
Blimp aerial photograph of section of Wind Creek, 12 April 2006.

- Does indicate changes
 - Large changes are visible
 - Cannot discern small changes

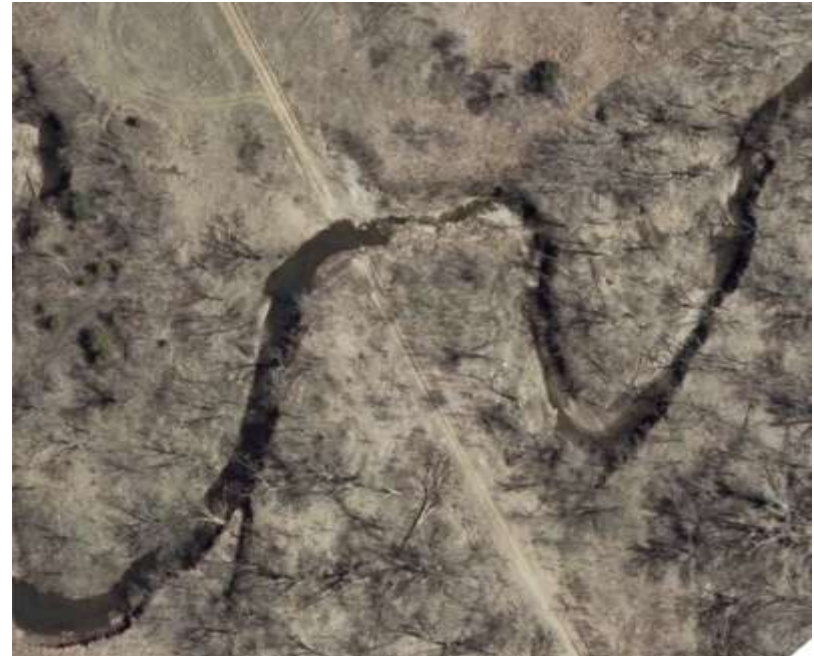
2010 orthophotography of the same area as the 2006 image (left).

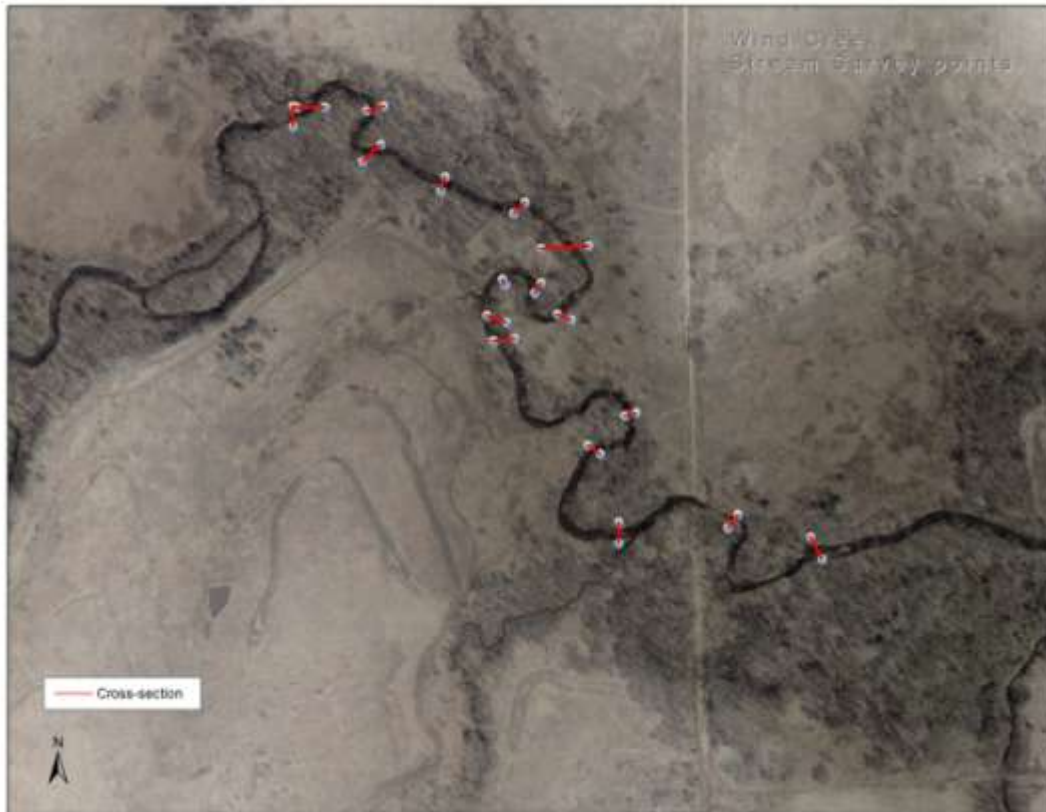
2010 orthophotography of Wind Creek with cross section survey points plotted.

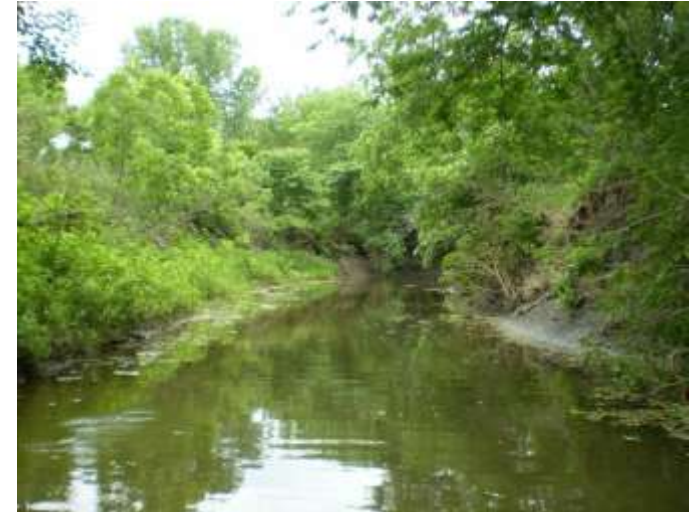
Downstream view from the last cross section on a study reach on Wind Creek toward the site of soil loss.
