# Measuring Streambank Erosion Bank Profiles to more Robustly Estimate Recession Rates and Calibration of the AnnAGNPS-CEAP Model

Clare Prestwich, P.E.<sup>1</sup>

W. Barry Southerland, Ph.D.<sup>2</sup>

Water Quality and Quantity Technology Team  
NRCS -West National Technology Development Center

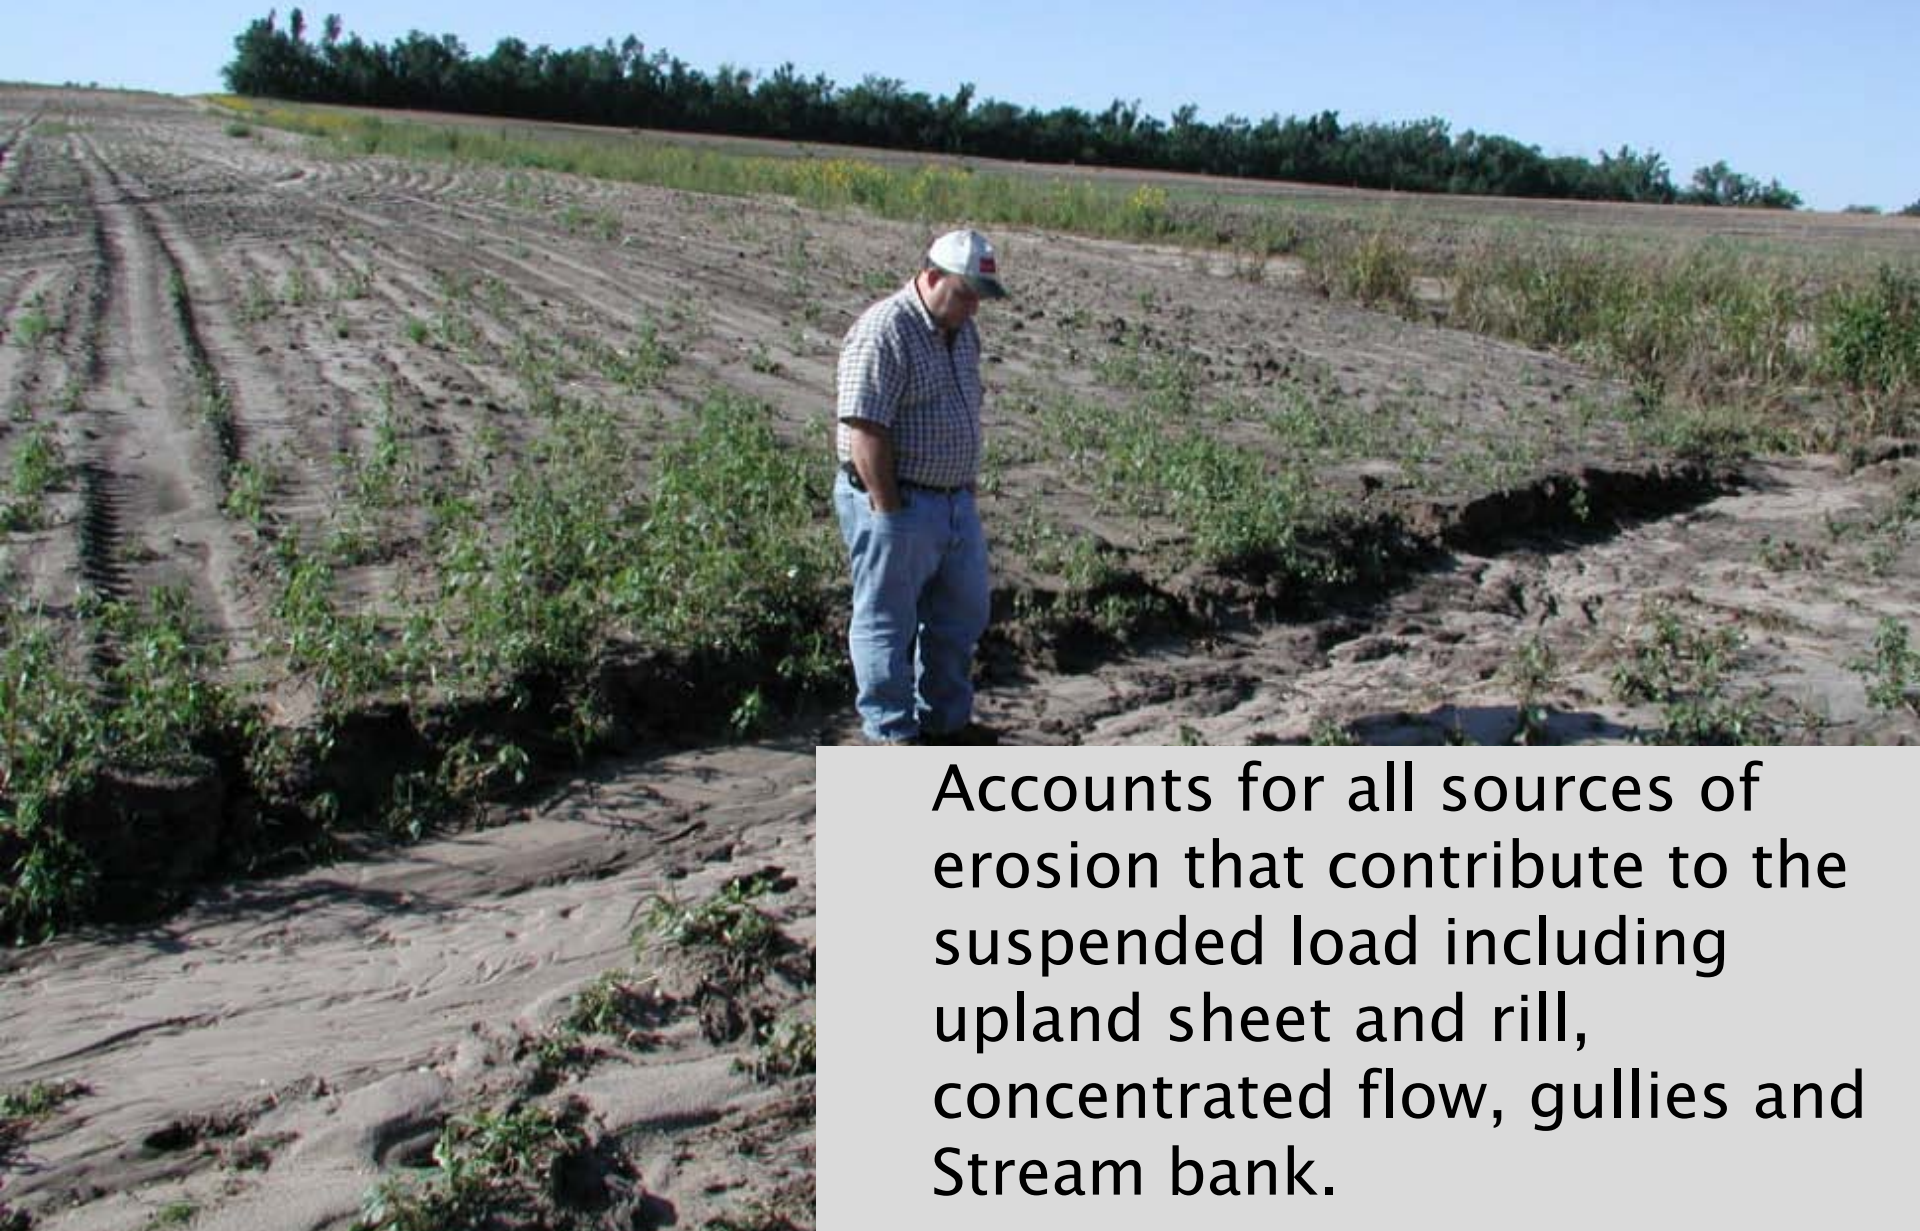
Accounts for all sources of erosion that contribute to the suspended load including upland sheet and rill, concentrated flow, gullies and Stream bank.

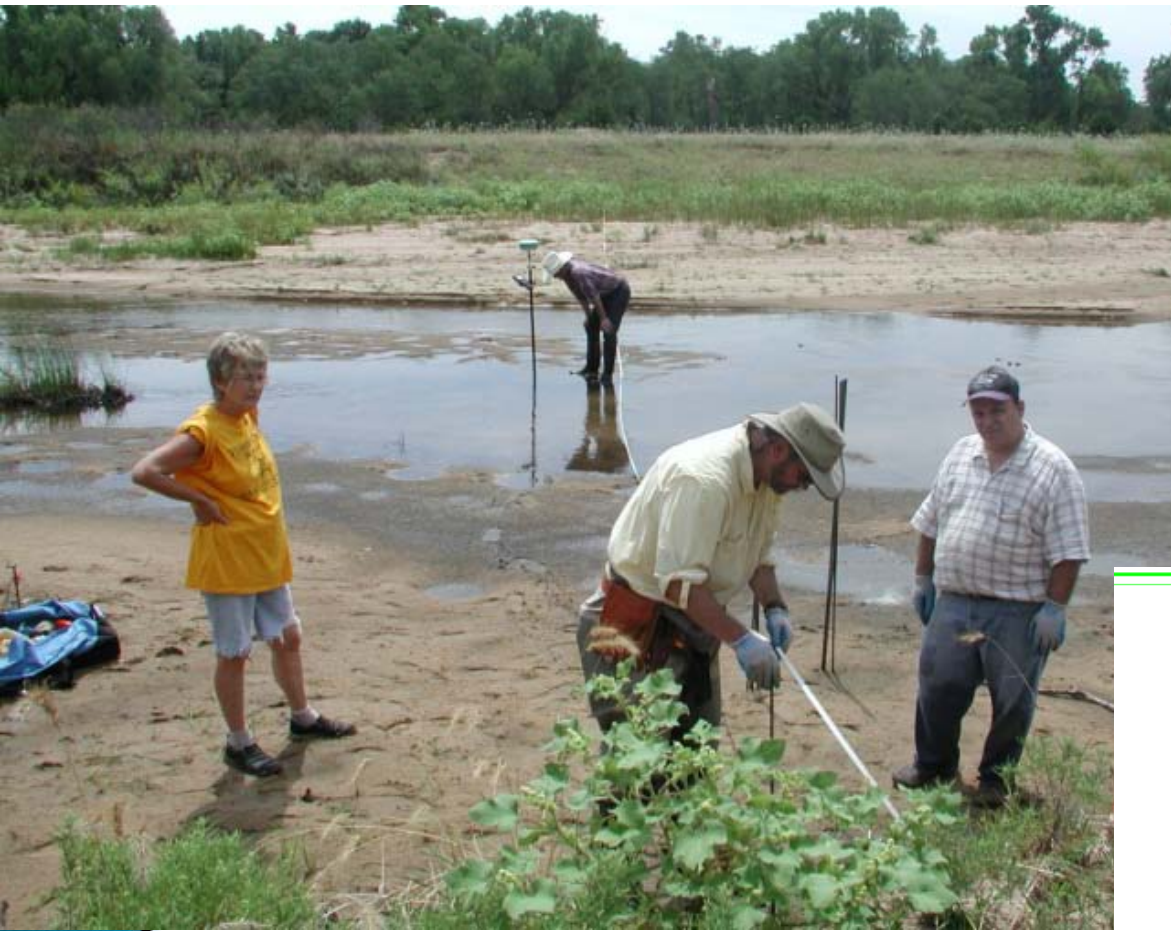
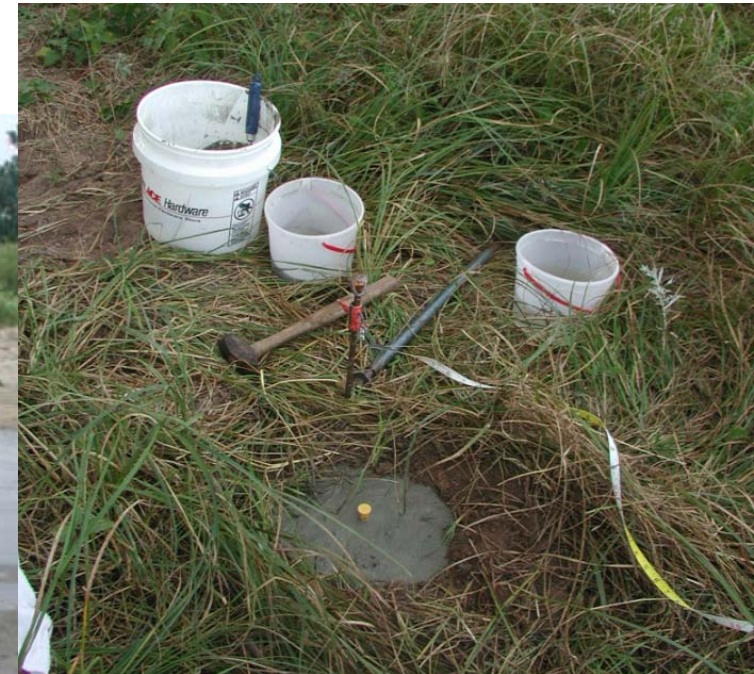
# Cross Sections with permanent Bench marks

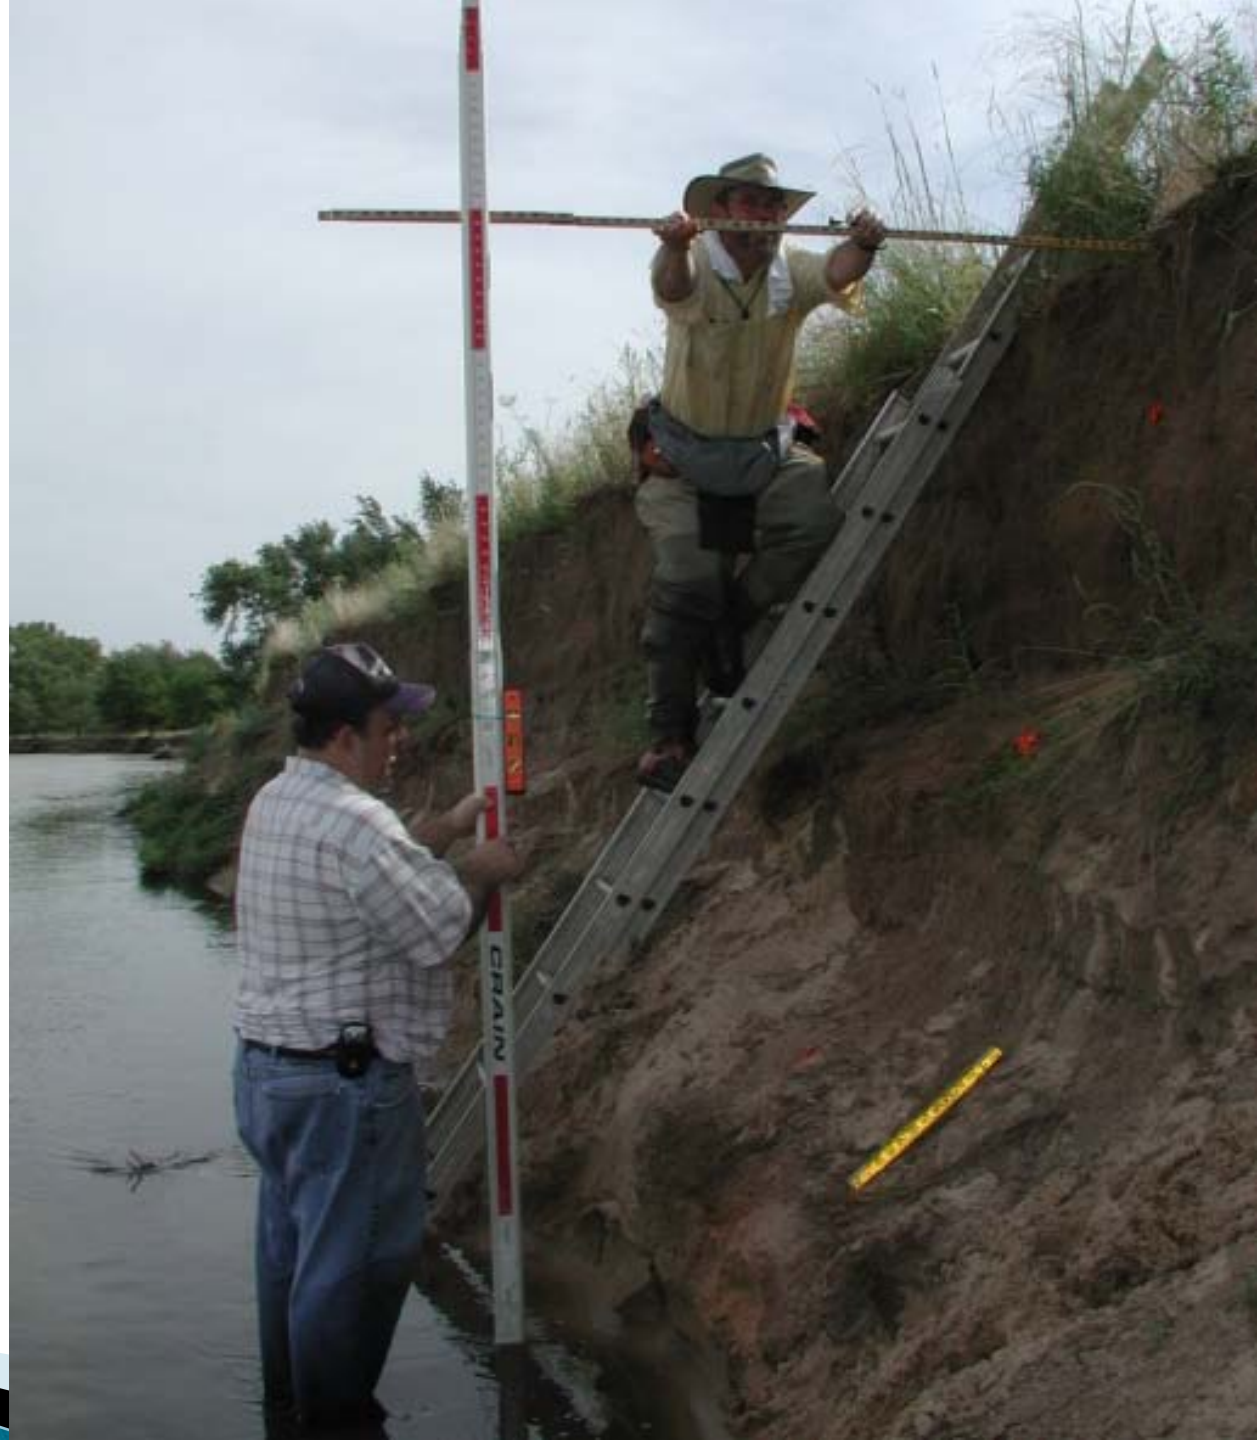
# Bank pins installed

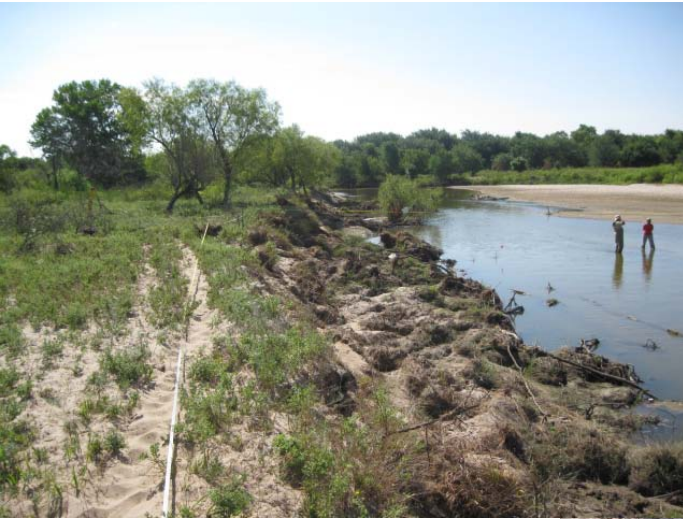
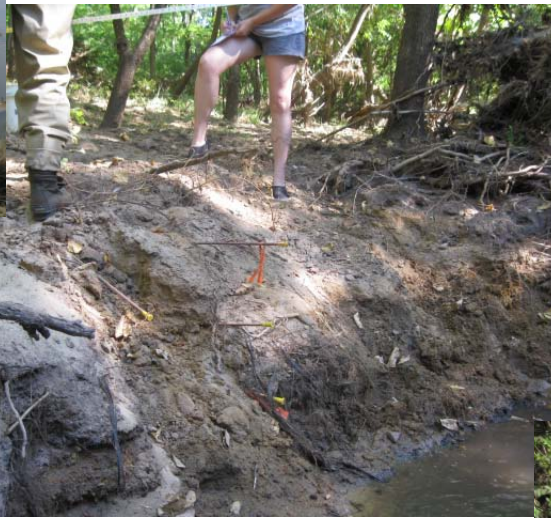
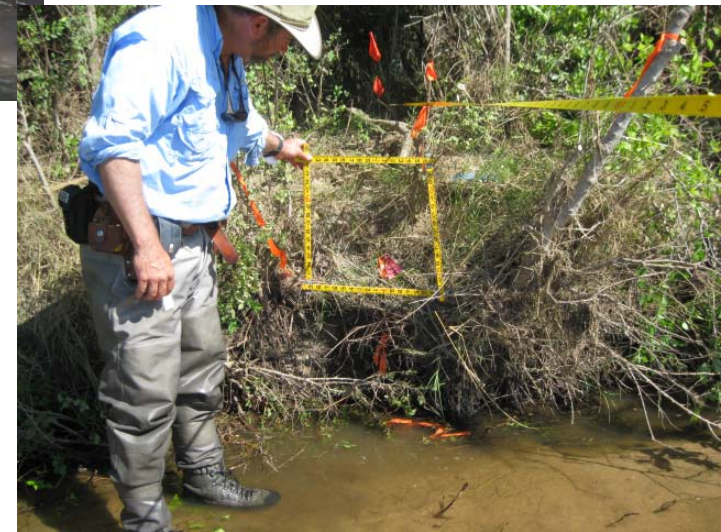
# Range of Data was collected

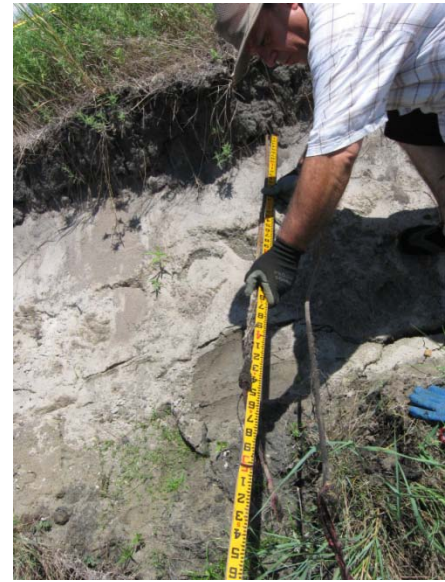
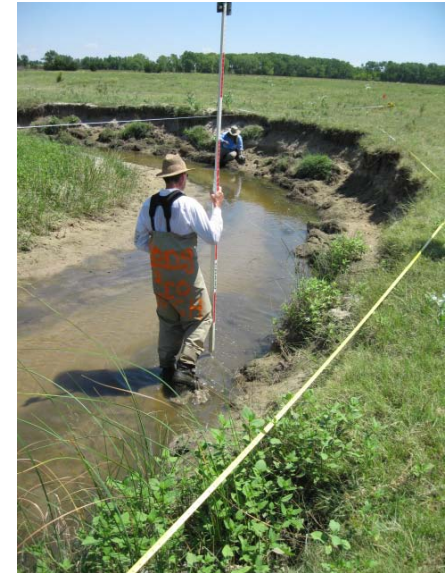
- ▶ Streambank erosion pin measurements and bank profile form and measurement.
- ▶ Morphometry of dimension (cross-sections, long profile, and pattern).
- ▶ Particle size distribution– bed and banks
- ▶ Bank Erodibility Hazard Index rating/scoring
- ▶ Bank erosion pins reset annually for 5 years
- ▶ Shear plain length assigned to pin set
- ▶ Floodplain connectivity – bank height ratios
- ▶ Mechanism of failure, Geom. Classification, transition state and Schumm CEM stage

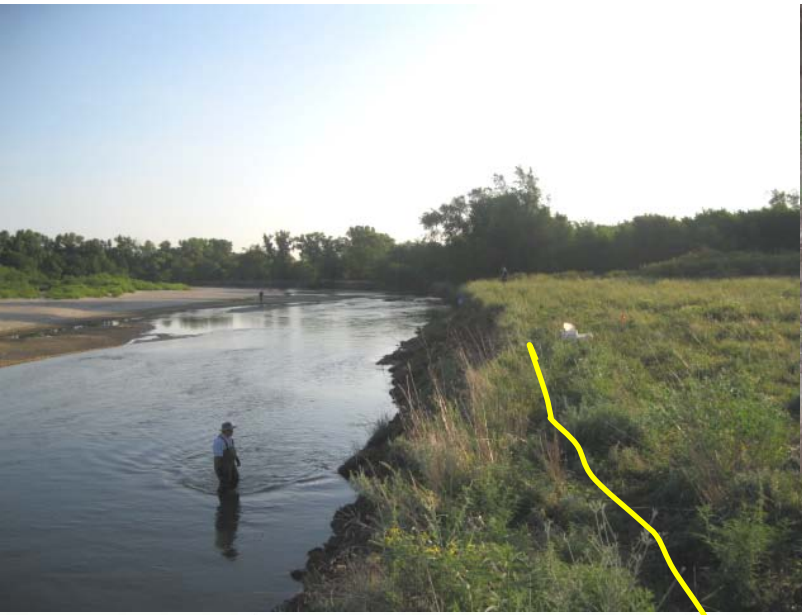
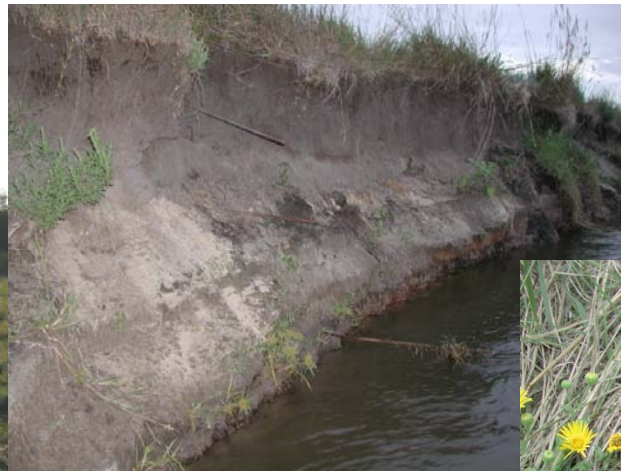
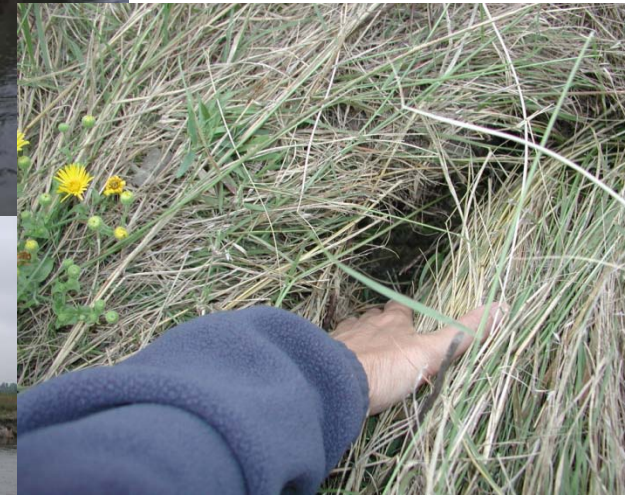
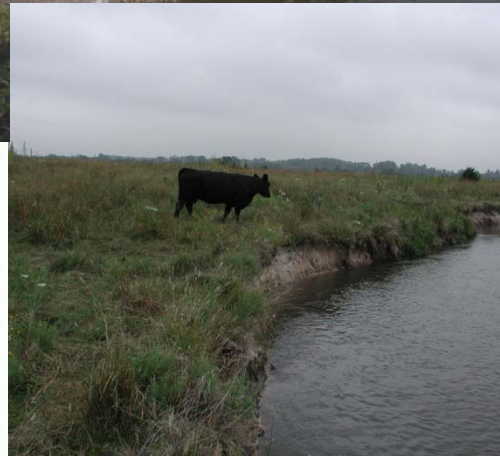
# Mechanism of Bank Failure

## WEDGE FAILURES I

PLAINER FAILURE  
USUALLY WITH STEEP OR  
NEAR VERTICAL BANK

## CANTILEVER FAILURE

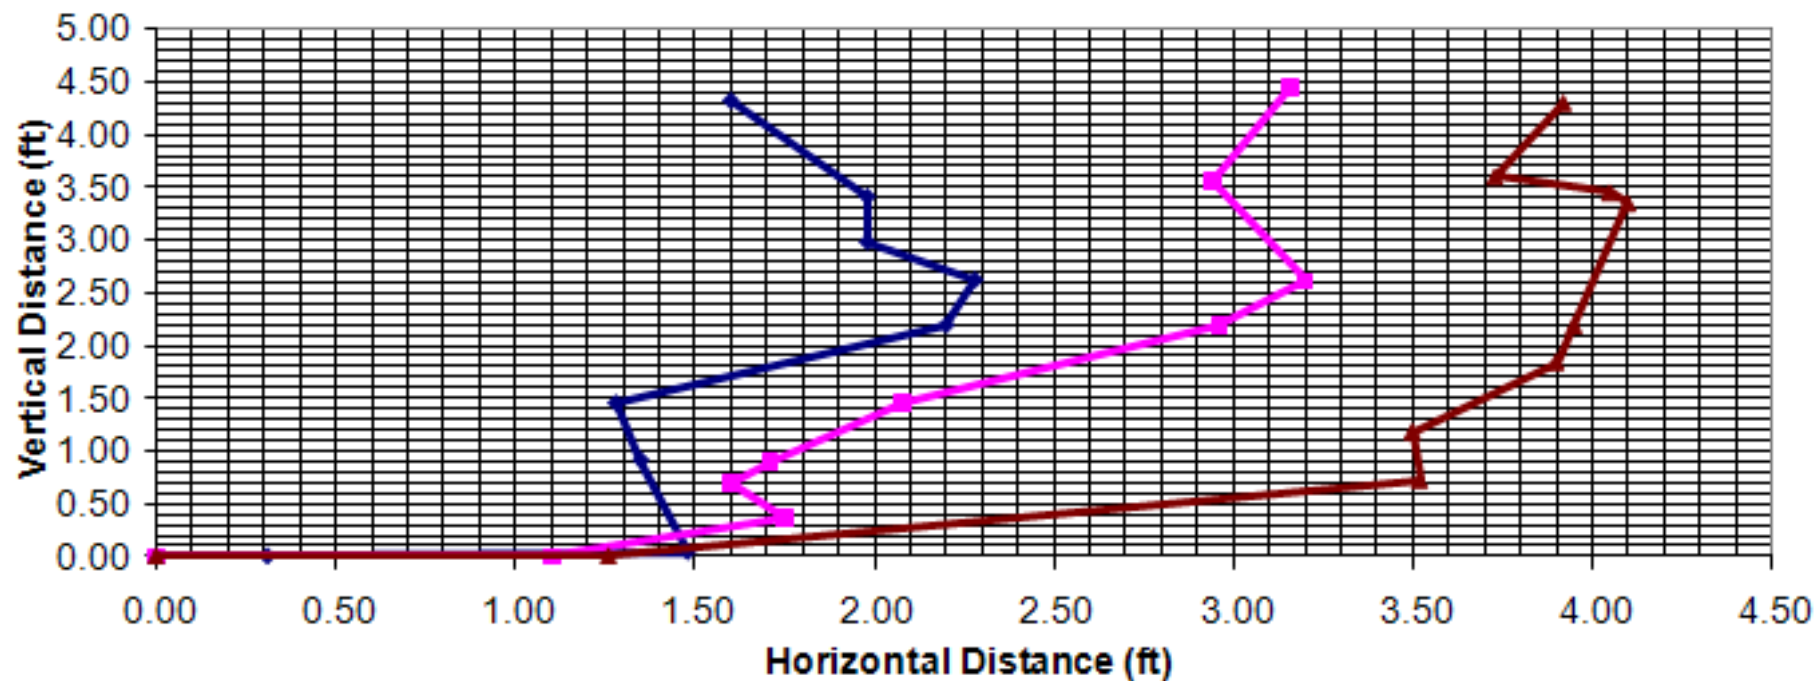
# Silver Creek condition class – Severe

**Vertical Bank Profile**

Recession Rate

Recession Rate based on Polyginal Area  
Area (sqft)

Recession Rate based on pins  
Rate (ft/event)
